HERITAGE STATEMENT

Home Farm, North Green, Parham IP13 9NR

September 2019

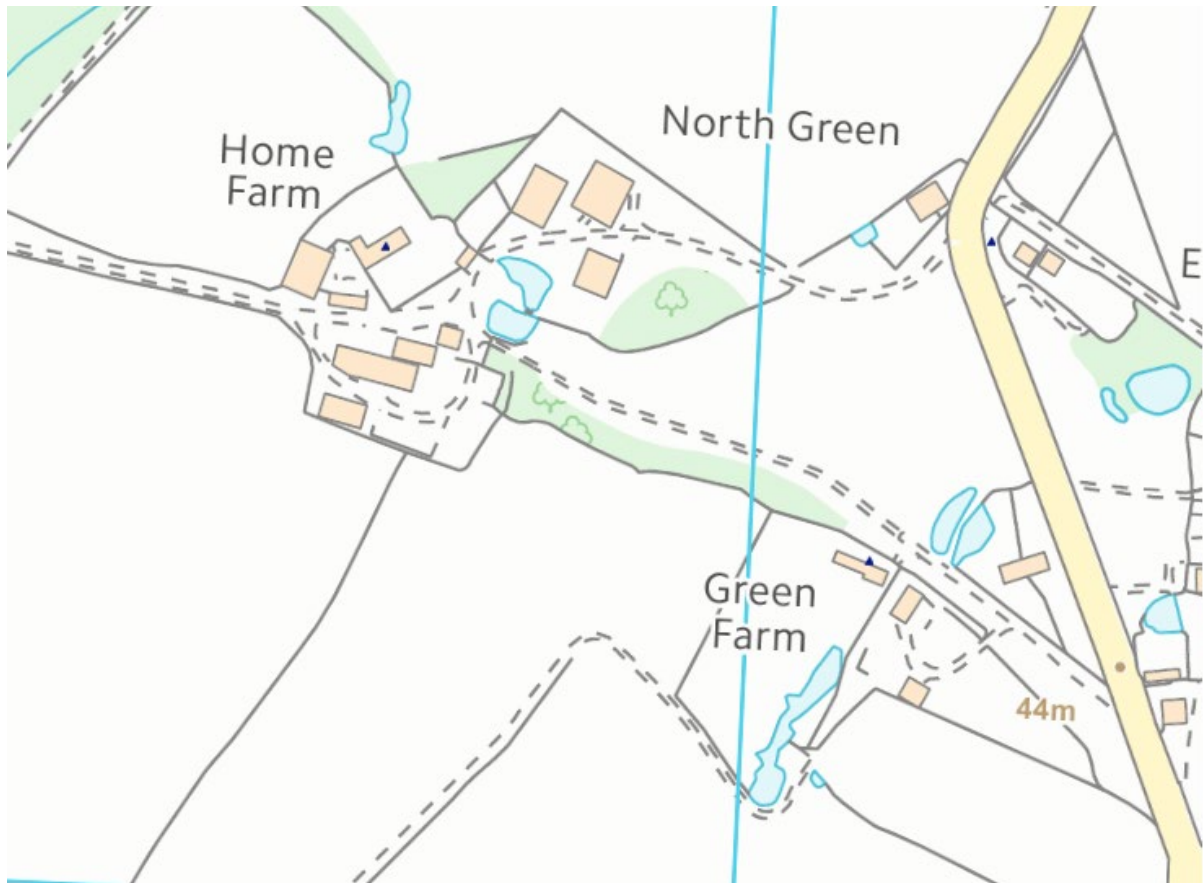
2.1 The above map extract identified the listed buildings on or in the close vicinity of the site. These are as follows:

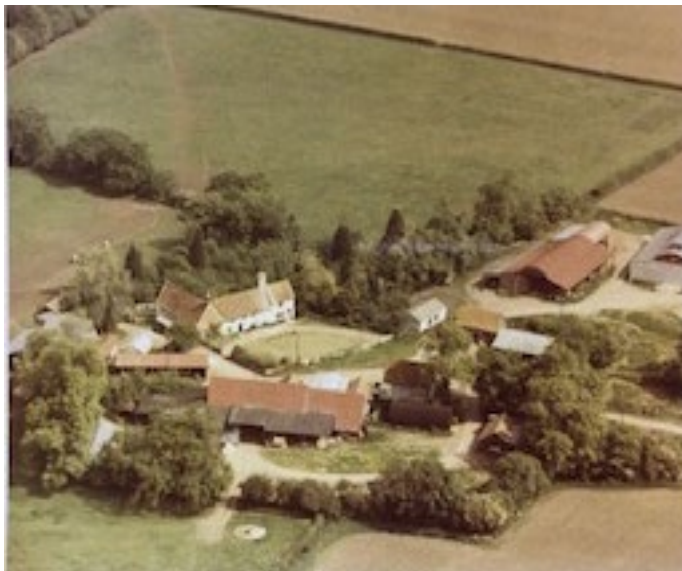
Aerial photo - 1964 of the farmstead (B Briscoe)

constructed to the south and east of the farmhouse and the silo erected. This map provides a good comparison with the aerial photo above.

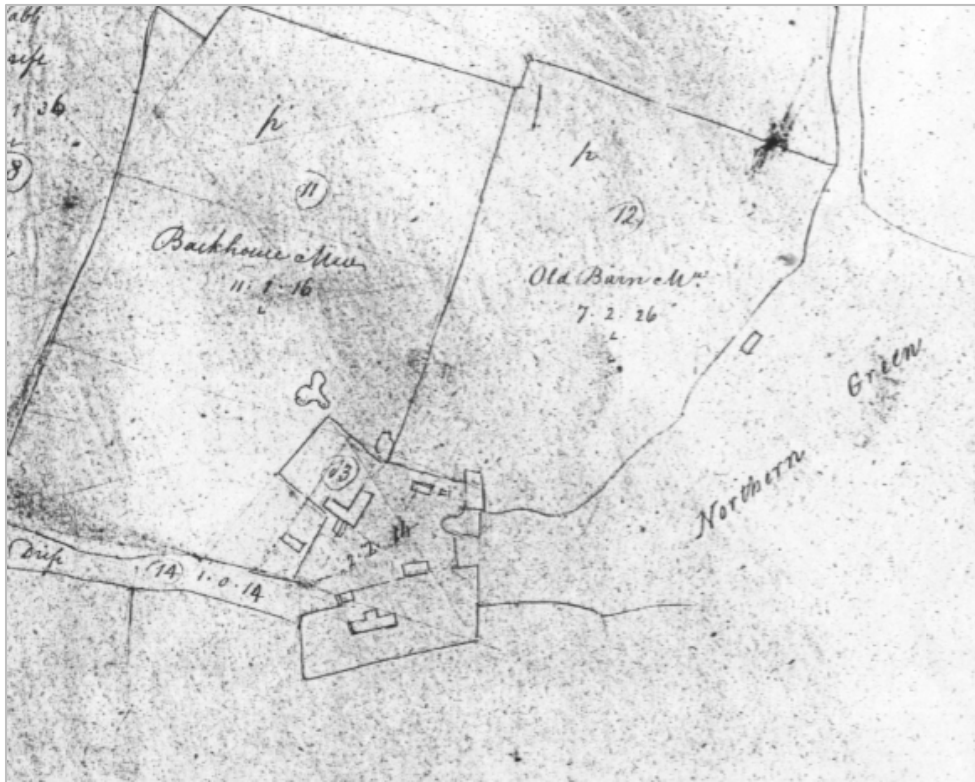
3.7 The earliest detailed map is that of 1824 which part of a survey of the farm was. The farmhouse is the L shaped building to the north west of the dispersed yard of farm outbuildings. The proximity to the northern green is clearly shown on this map.

1824 survey map of North Green Farm (SRO)

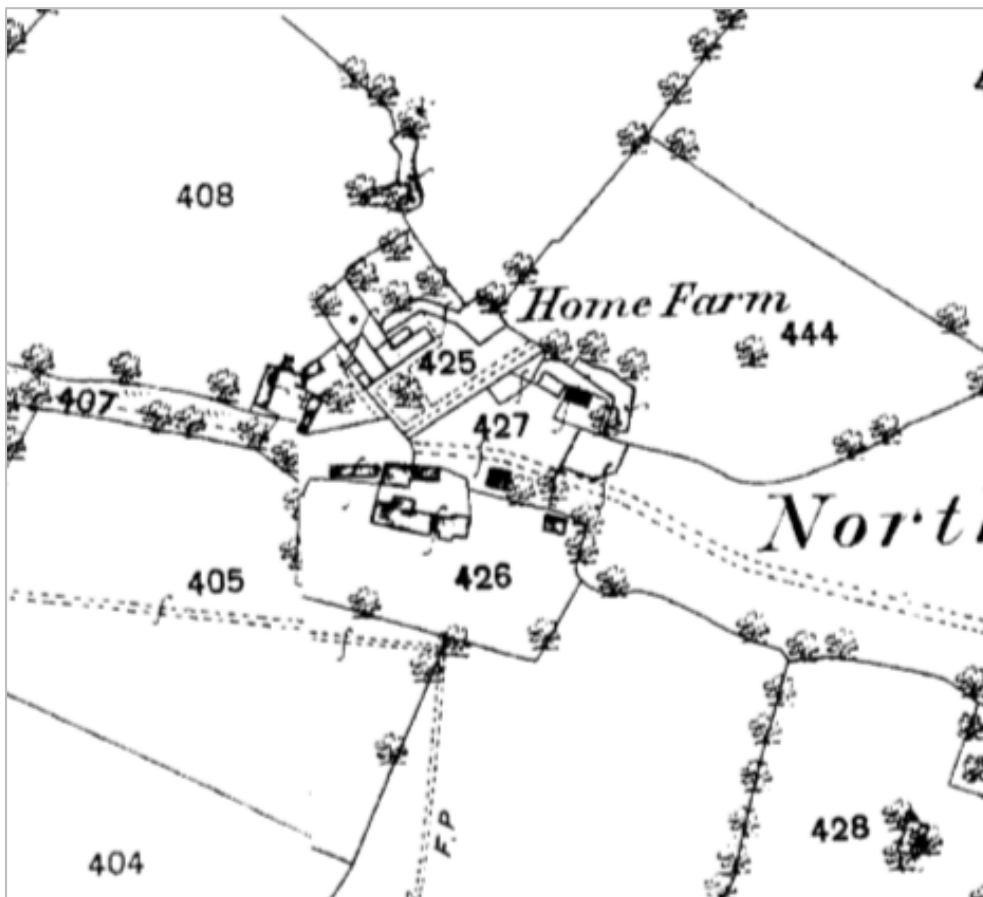
OS Map 1883 (Old Maps)

3.8 The First Edition OS map for the area dates from 1883 and provides a more accurate representation than the sketch map. The farmhouse to the north of the yard is clearly denoted as an L shaped building with an adjoining cross-wing and rear addition along part of the rear elevation. The front elevation is very clearly to the southern side with an enclosed garden area and pathways leading to the main entrance of the house. The cross-wing was known to have been separate from the house and provided non-habitable space with no internal physical links with the main house until the C20. Adjacent to the western wing a side addition is denoted which is on line to the southern front elevation. The 1883 map shows the former moat to the north of the house more clearly and illustrates how close it was to the rear (northern) elevation of the house. The orchard area to the north of the house is also clearly denoted.

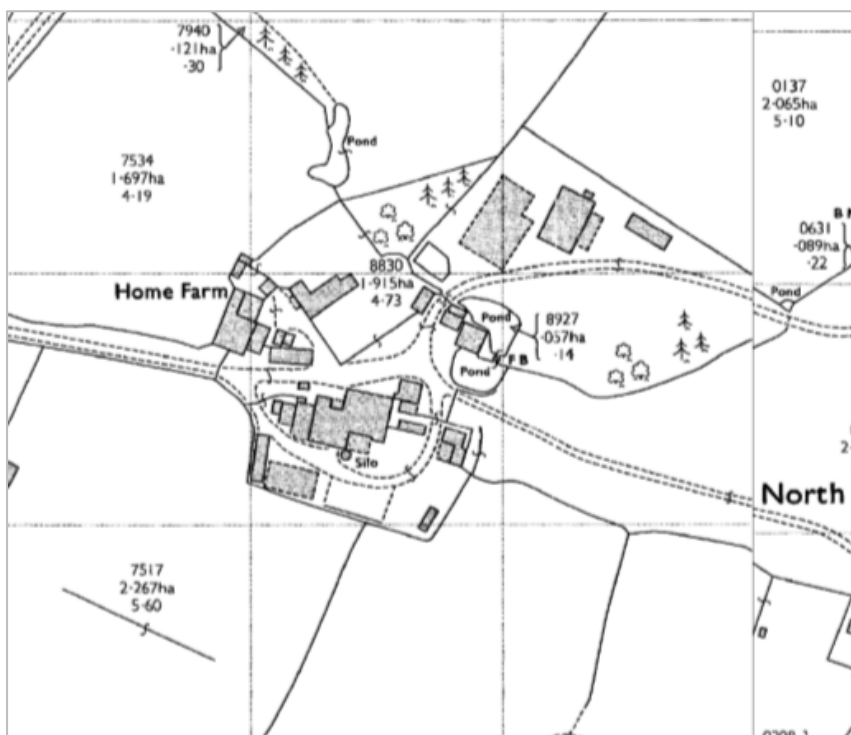
OS Map 1975 (Old Maps)

3.10 The fourth and final plan in the OS series dates from 1975. Here one can see significant changes to the farm out buildings with a number of modern barns being

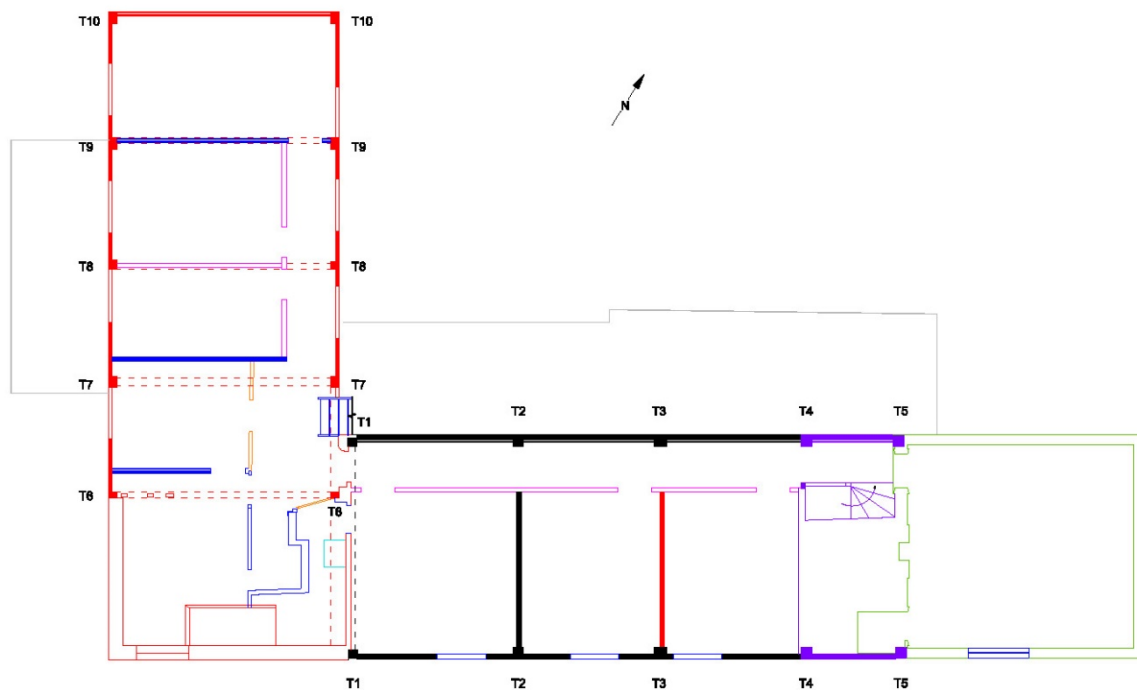
GROUND-FLOOR PLAN

4.12 The following interim dating diagram has been produced by Jane Briscoe.

4.13 In summary the old core of the building focuses on the central section of the building where the cross passage is located and which is considered to be late medieval in date. The house was extensively enlarged in the C17. In the C19 the house appears to have been subdivided into two units with evidence of an additional staircase surviving. It was returned to being one unit in the C20. The C20 works have largely sought to improve the living accommodation within the building.

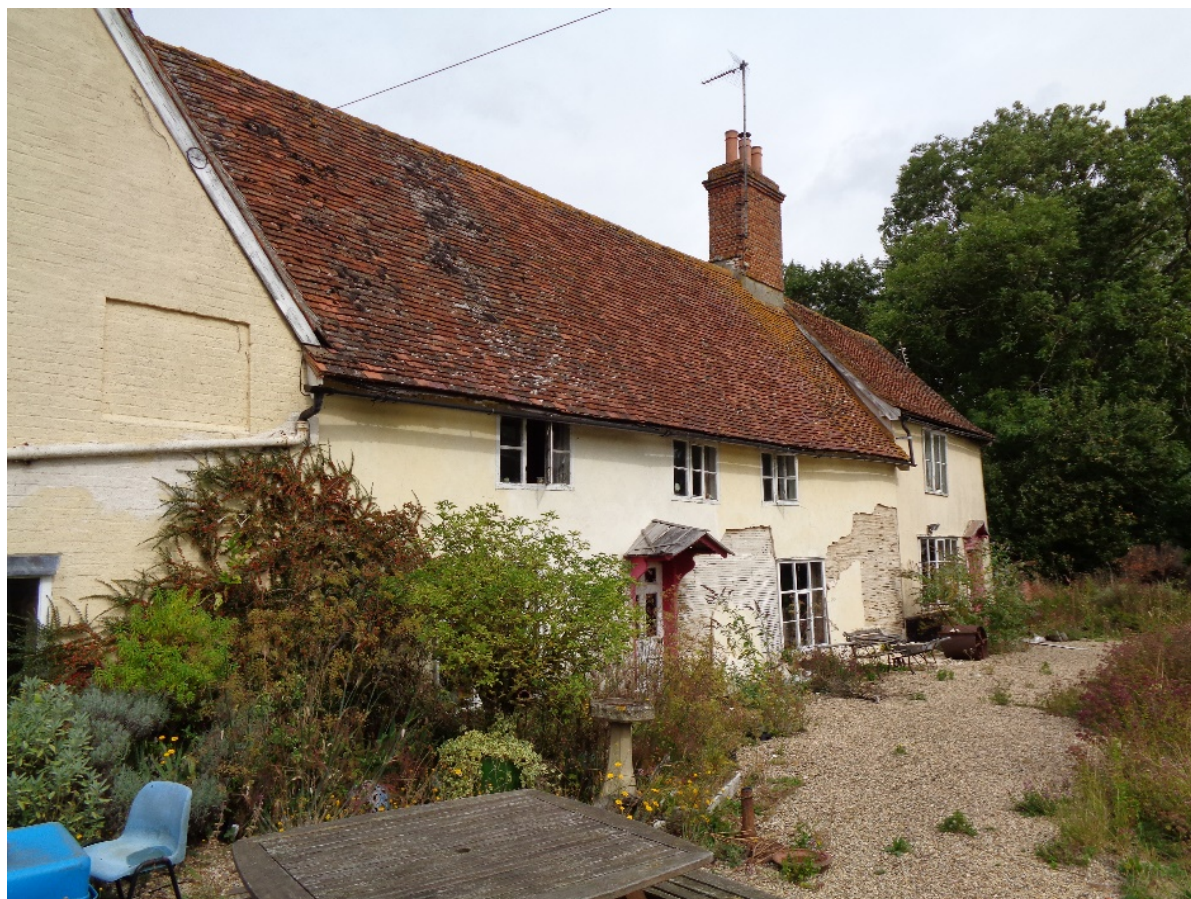
Front elevation

4.15 The front elevation is where the component elements of the building are best viewed, with the central historic core with the cross passage denoted by the location of the front door. The central part of the building contains no chimney stacks adding to the evidence that this was a hall house, with the stacks added as part of the additions at each end of the central core.

4.16 The small windows located tight to the eaves line are indicative of an inserted floor and although the fenestration is modern the openings are considered to date from the flooring of the building when a series of room with windows to the front and rear elevations were created.

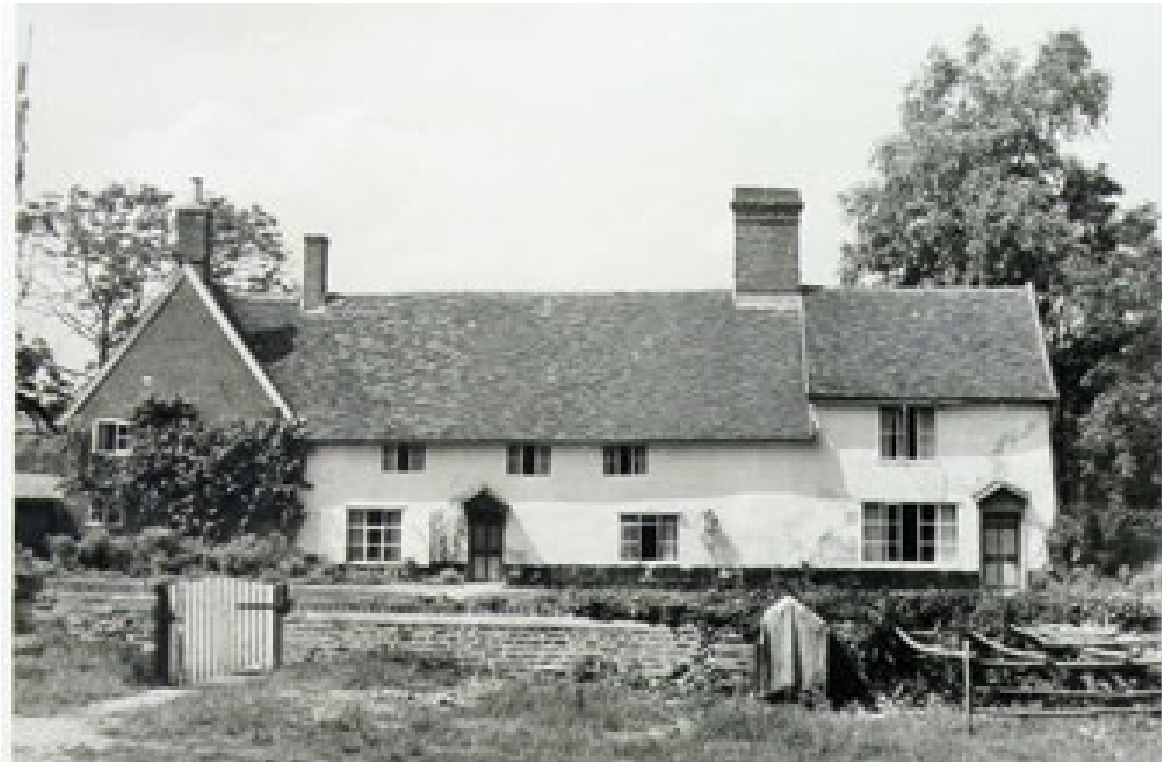
South Elevation undated photo Historic England Collection (Red Box) 1948

4.17 The brick gable end to the cross-wing forms a distinctive element to the principal elevation and serves to distinguish between the historic living space in the rendered part of the building with the brick element being the service and storage part of the building.

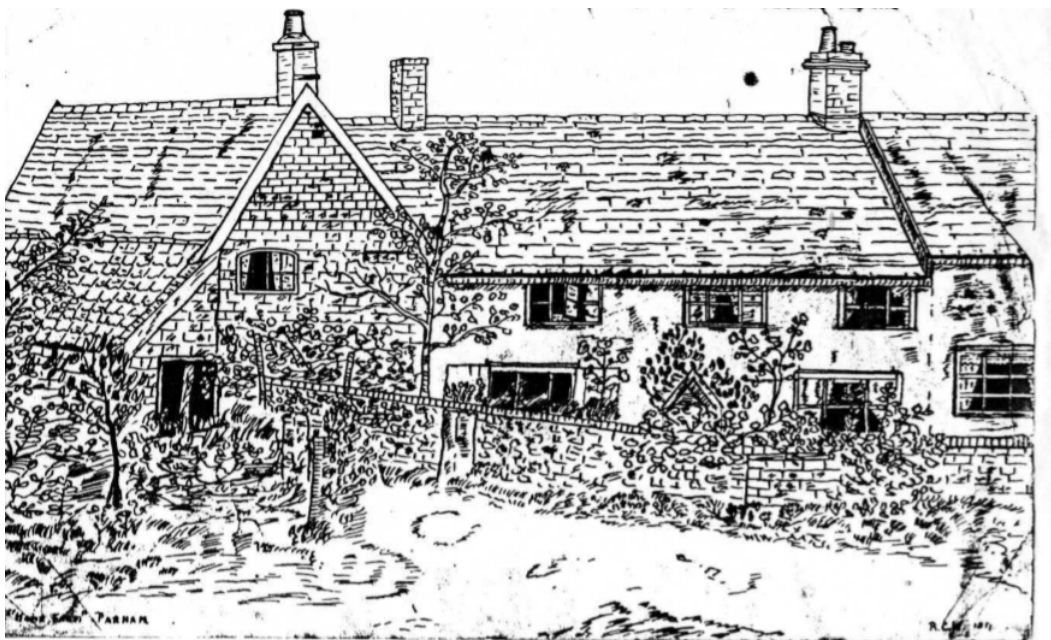
2 Sketch of the front elevation dated 1921

4.18 The sketch of 1921 is very similar to the Historic England Collection photo. It should be noted that the ground floor windows had been enlarged and altered by this time. The 'blocked' window to the brick gable has never been a window given its location to the attic stairs and the chimney stack to this cross-wing.

4.23 The western elevation of the cross-wing has had the mullion windows exposed. The composition of this elevation has changed over time as the 1921 sketch above denotes. There was formerly a single storey extension to this elevation which was located further south than the present porch, and flush with the front gable end (see sketch above). This meant that there was one window to the front elevation lighting what is today the kitchen area. The side window to this room is a mid C20 addition. The extension is considered to have no significance.

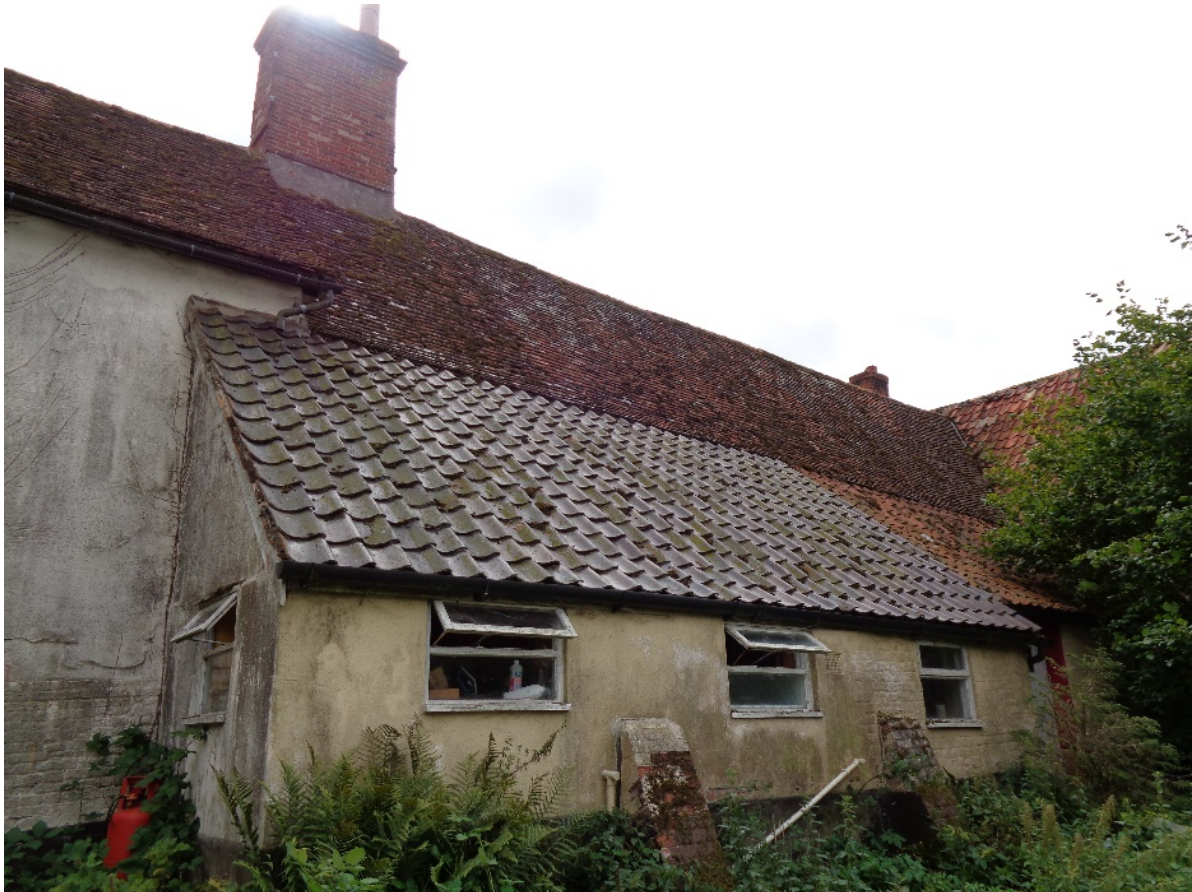
Rear elevation

4.19 The rear elevation of the original building has been largely concealed by the addition of a lean-to linear single storey range. This structure is not of one build as the internal exposed framing reveals and has been much patch repaired over time such that it is considered to have only local significance. The main two storey elevation is assessed as having some significance. The revealing of currently blocked-up rear mullion windows at eaves level provides potential to restore some of the significance to this elevation.

4.20 The infilling of the moat in the early C20 and relationship of the farmhouse to this feature has also altered the appearance and reduced the significance of this elevation.

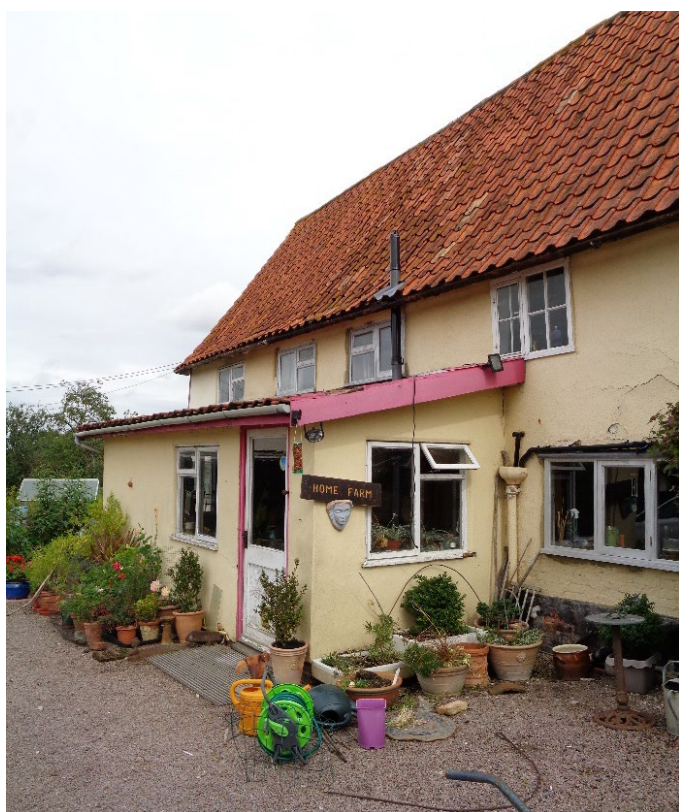
Western side elevation

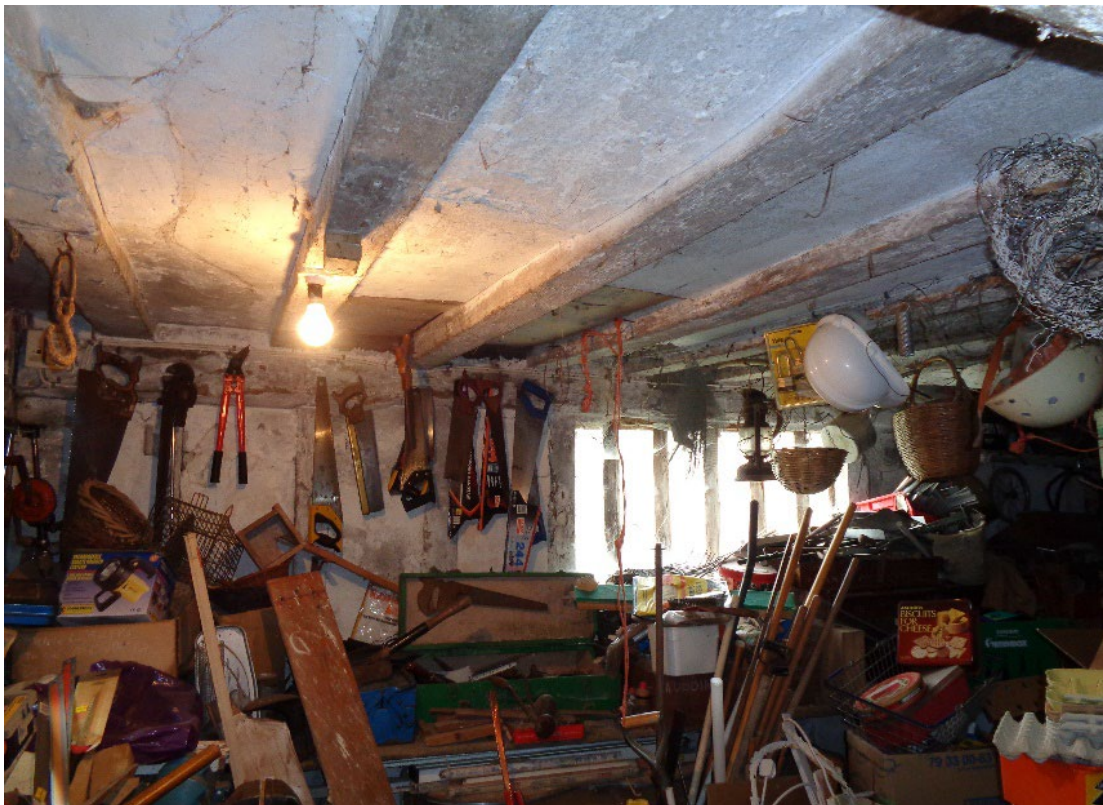
Interior of workshop

4.26 The workshop remains largely unconverted. The main intervention dates from the C20 when the pantry was formed. The original windows have been exposed internally and externally but the space remains non-habitable. It has some local significance as a traditional farm storage area dating from the C17.

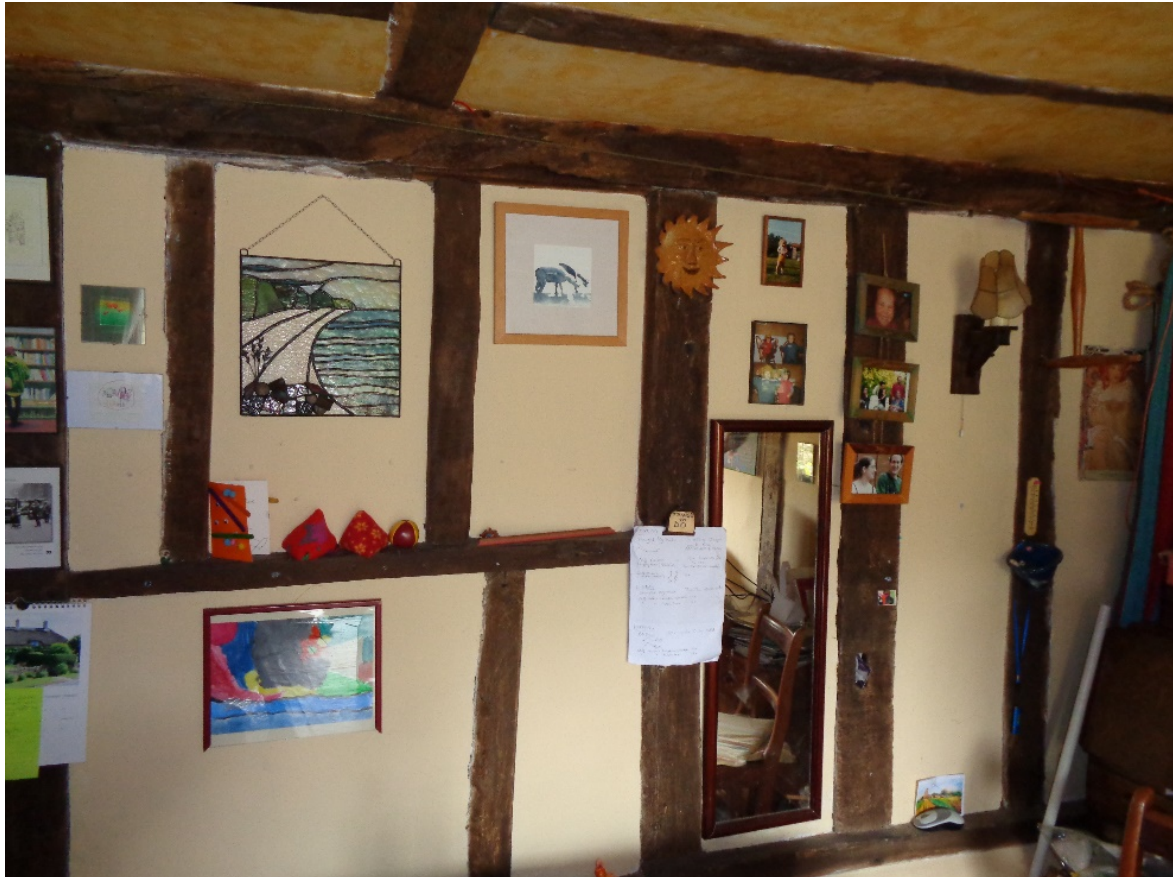
Framing to the living room

4.27 The living room is within the core of the house and retains exposed timber framing including close studded wall framing and floor joists. There is evidence of blocked windows and the location of an earlier stair case. The jowl posts are of interest. There is no surviving hearth to the room as it is understood this was blocked over in the 1970's. The chimney is thought to be early C20 so the hearth appears to be a later addition.

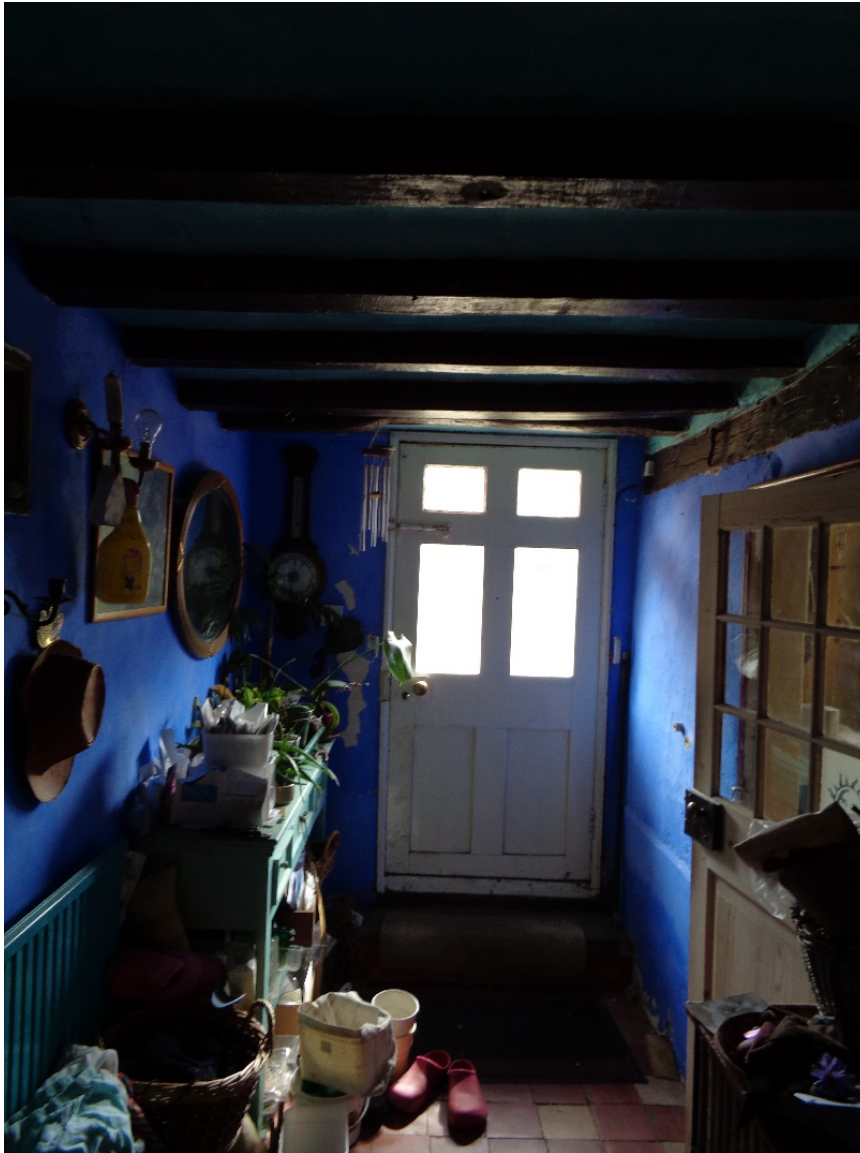
Cross passage

4.28 The hallway is considered be on the line of the original screens passage of the previous building and has been retained as part of the subsequent rebuilding phases. It would have defined the division between the high and low ends of the original house. Its survival as a feature within the floor plan is considered to have considerable significance.

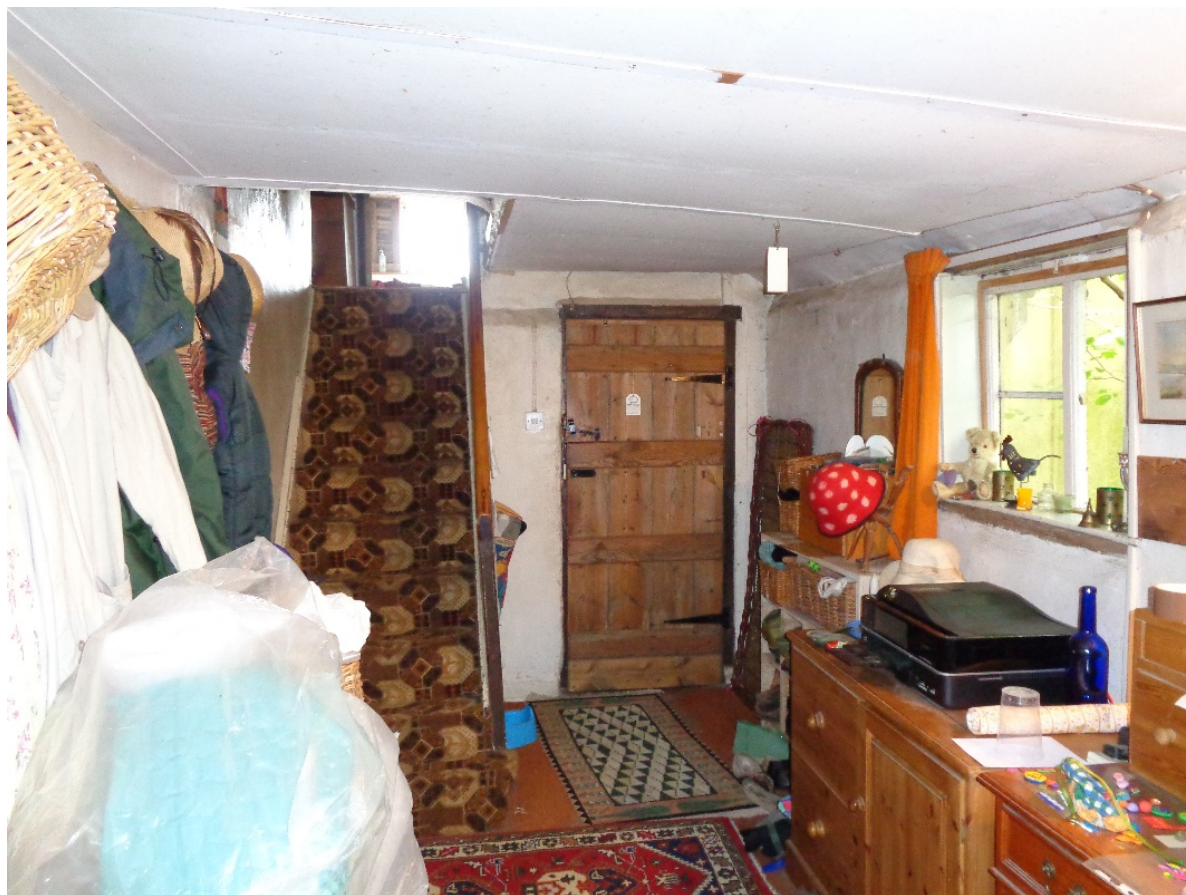
4.29 The rear lean to and stairs appear to be C19 alterations infilling the former rear open yard area and providing a covered link from the house into the cross-wing. The space has been modernised in the C20 with a metal framed window and recessed lighting to the ceiling.

4.30 The stairs provides the main access to the first floor but is of modest form and of low interest.

Back hall and stairs

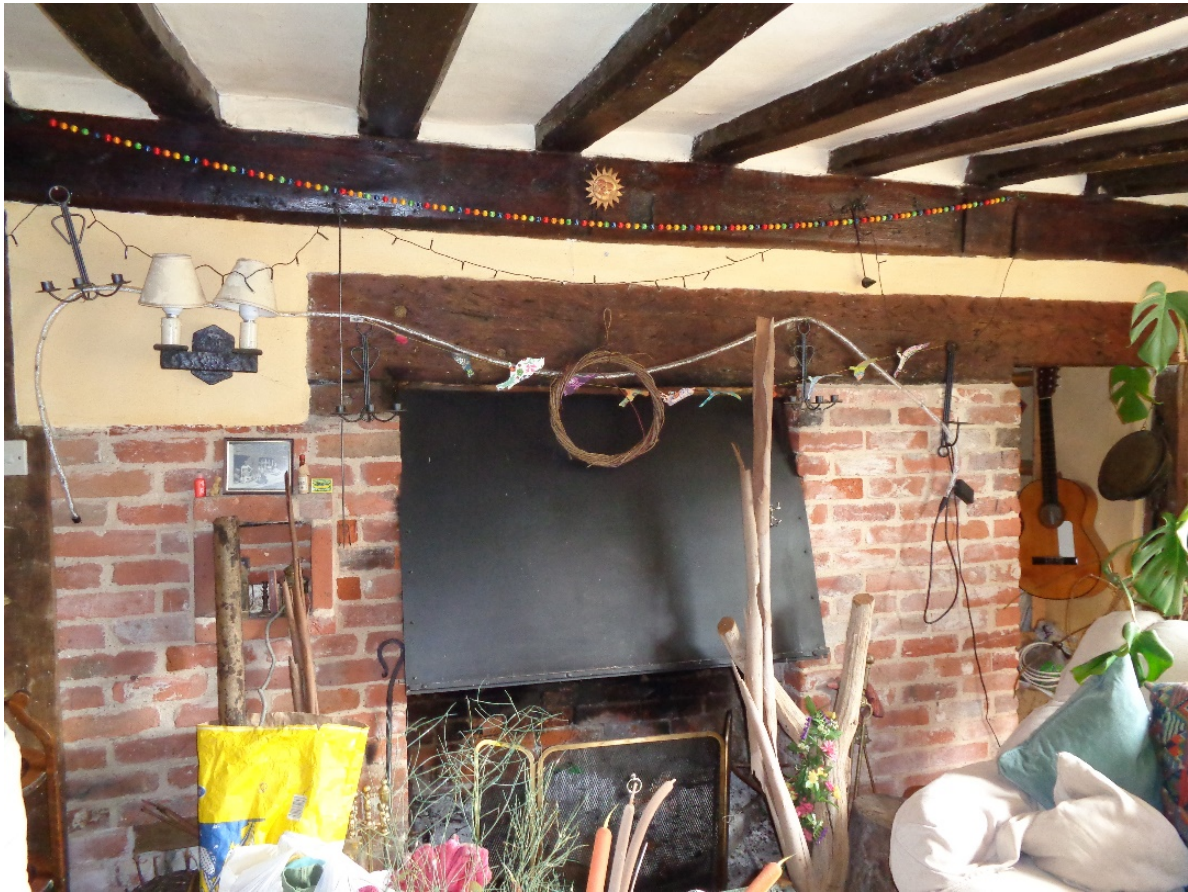
Hearth and surround to sitting room

4.32 This part of the house which is part of the C16 rebuilding of the property on the site of an early structure. The fireplace appears to have been constructed as a back to back inglenook as part of the second phase of C16 additions to the original 'high end' at the eastern end of the main range of the building. The exposed framing is of interest with the chamfered exposed beam running north south rather than east west. This is part of the strange phasing of rebuild and demolition to this part of the building as part of the 'progressive reconstruction of the hall house'. Jane Briscoe's work has identified further evidence for this at roof truss level which she considers was deliberately designed to allow for the full support of the roof without a full truss being incorporated. The two roof structures, although extremely similar in form, are not joined: the only points at which the south-western and north-eastern structures are joined are at the wallplates. The most likely explanation is that there was an existing structure against which the south-western part of the house was built, which was subsequently replaced.

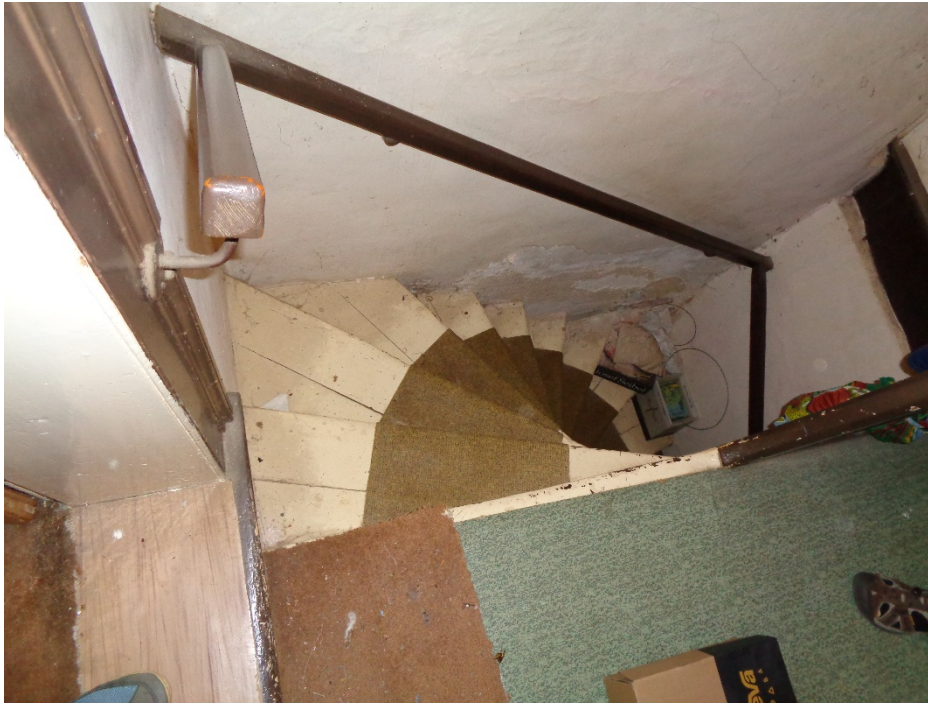
4.33 The addition of a staircase in the second phase of the C16 works indicates the building was floored sometime during this period. The location adjacent to the inglenook fireplaces, is a common location for stairs to be positioned.

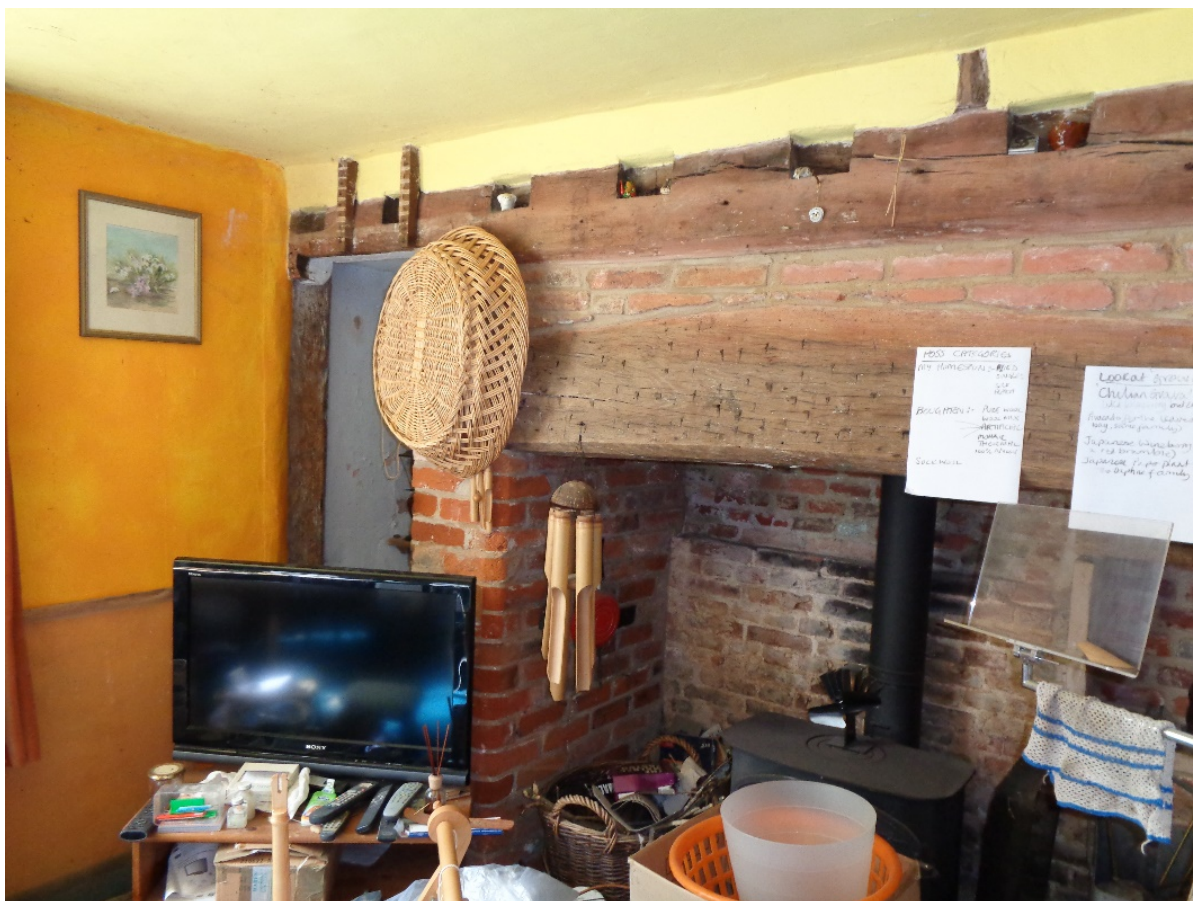
Inglenook fireplace to drawing room

4.34 The eastern most room which has three external walls is part of a C17 or C18 replacement of the eastern bay of the C16 house. The C16 inglenook fireplace and stairs were retained as part of this rebuilding. The inglenook within this room is in better condition than the sitting room although some of the brickwork to the southern end has been rebuilt. The framing to the room is largely concealed.

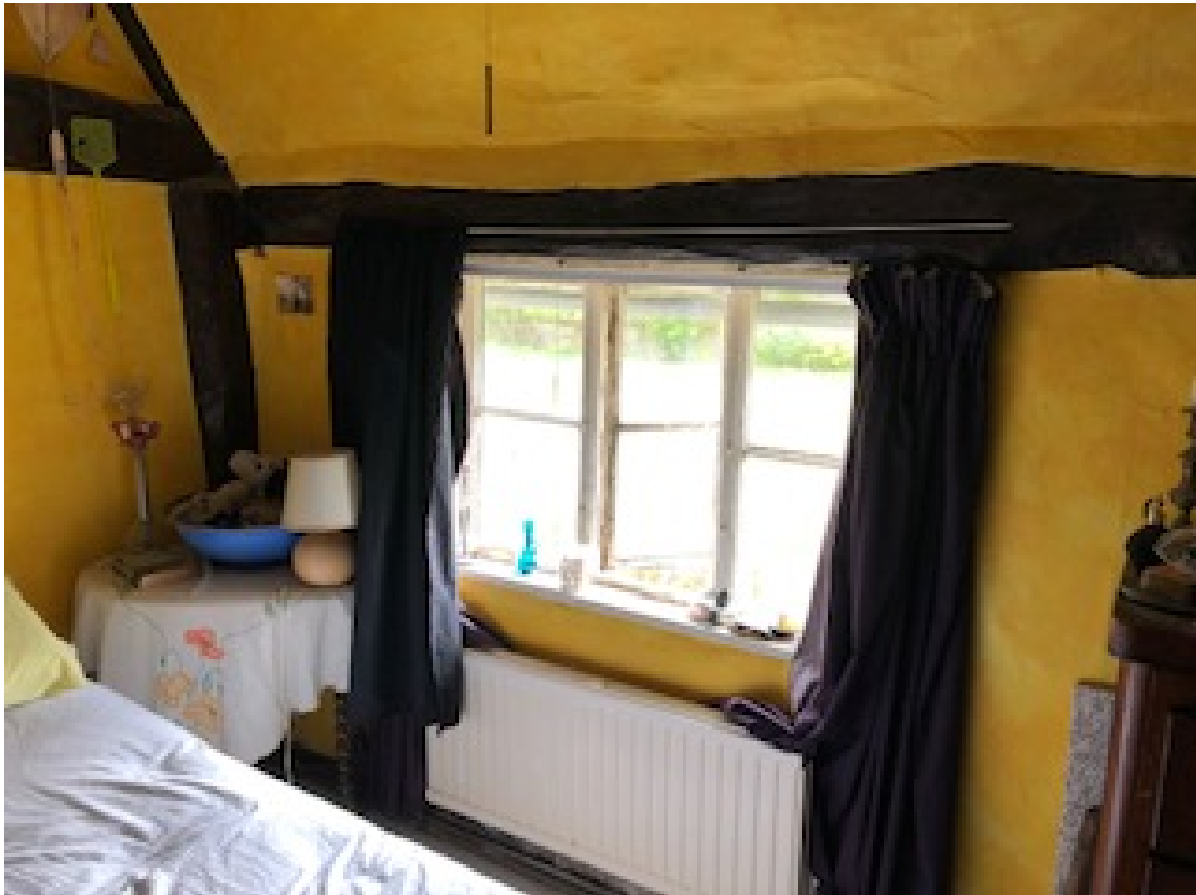
4.36 These three rooms have the framing exposed and have high ceilings with the lower framing of the C16 house. The central room has exposed wide oak boards. Although the form of the rooms have been altered by the formation of the rear corridor the character is retained with the retention of the small window openings and lath and plaster infill between the framing. The rear corridor is a dark windowless space with low ceiling height. The corridor is essential for circulation between the component elements of the building.

Central bedroom looking to front elevation

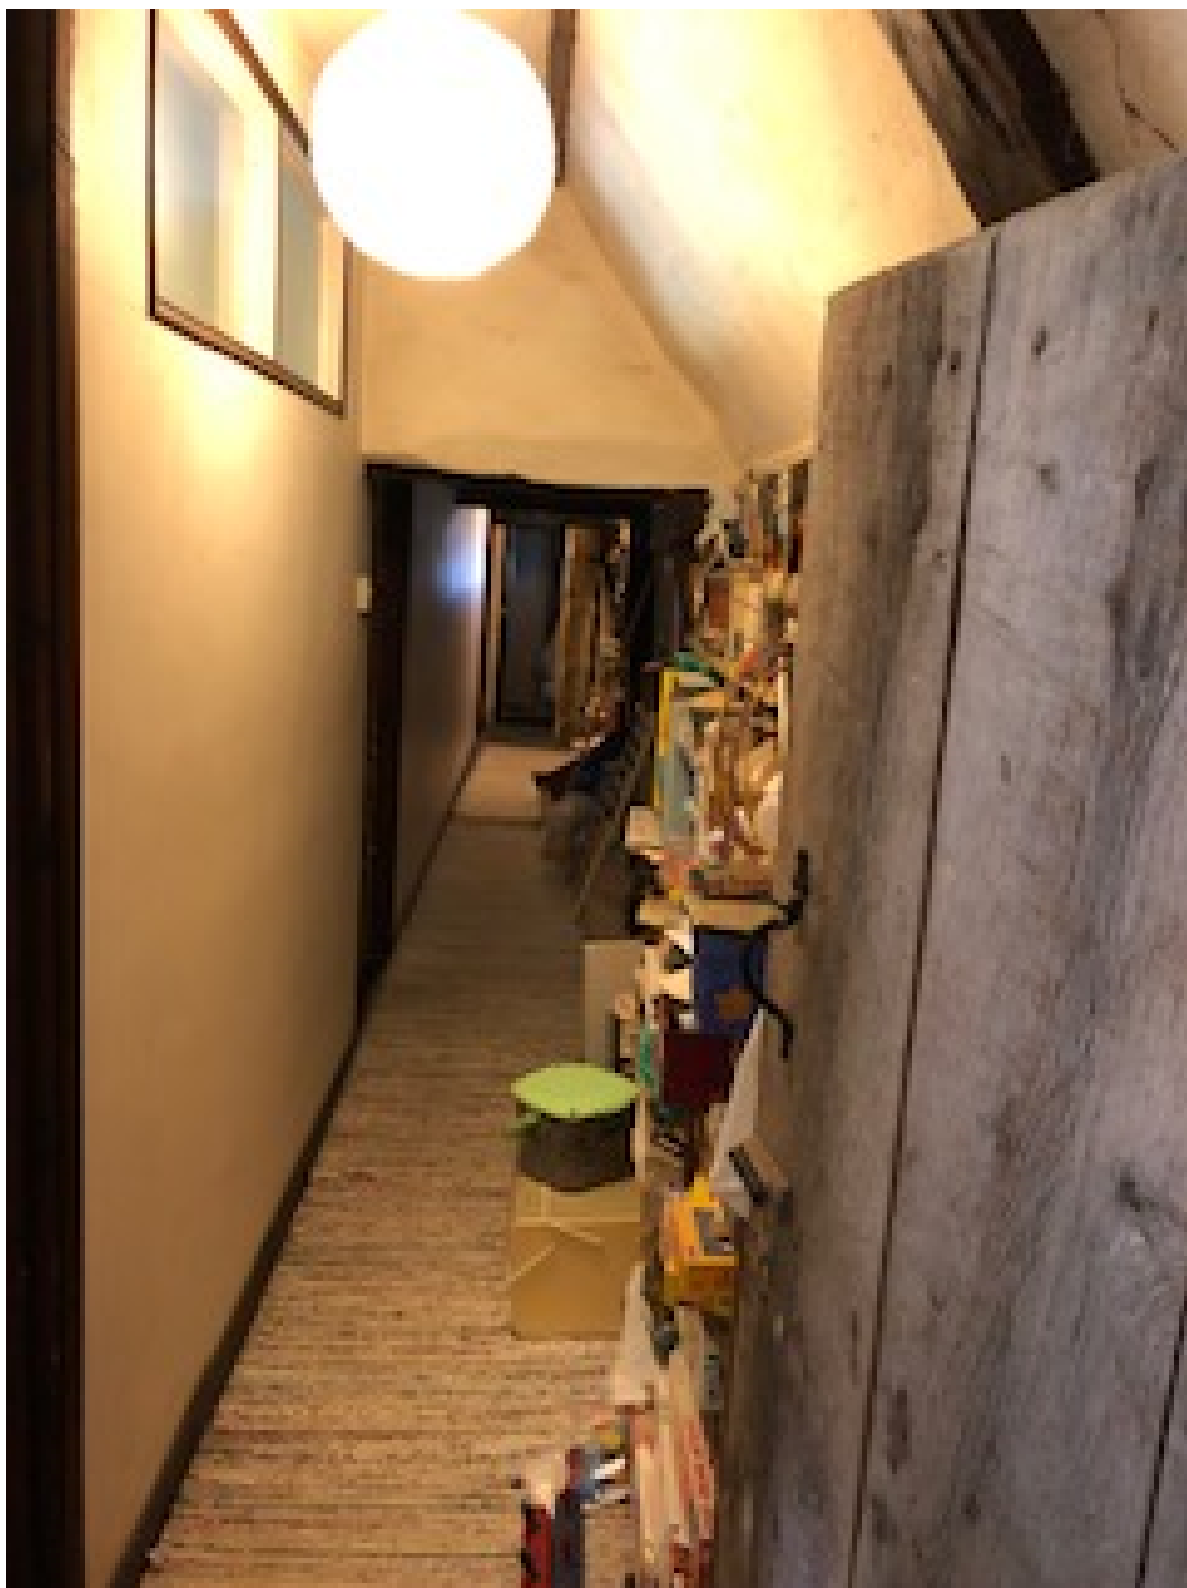
Rear corridor to central rooms

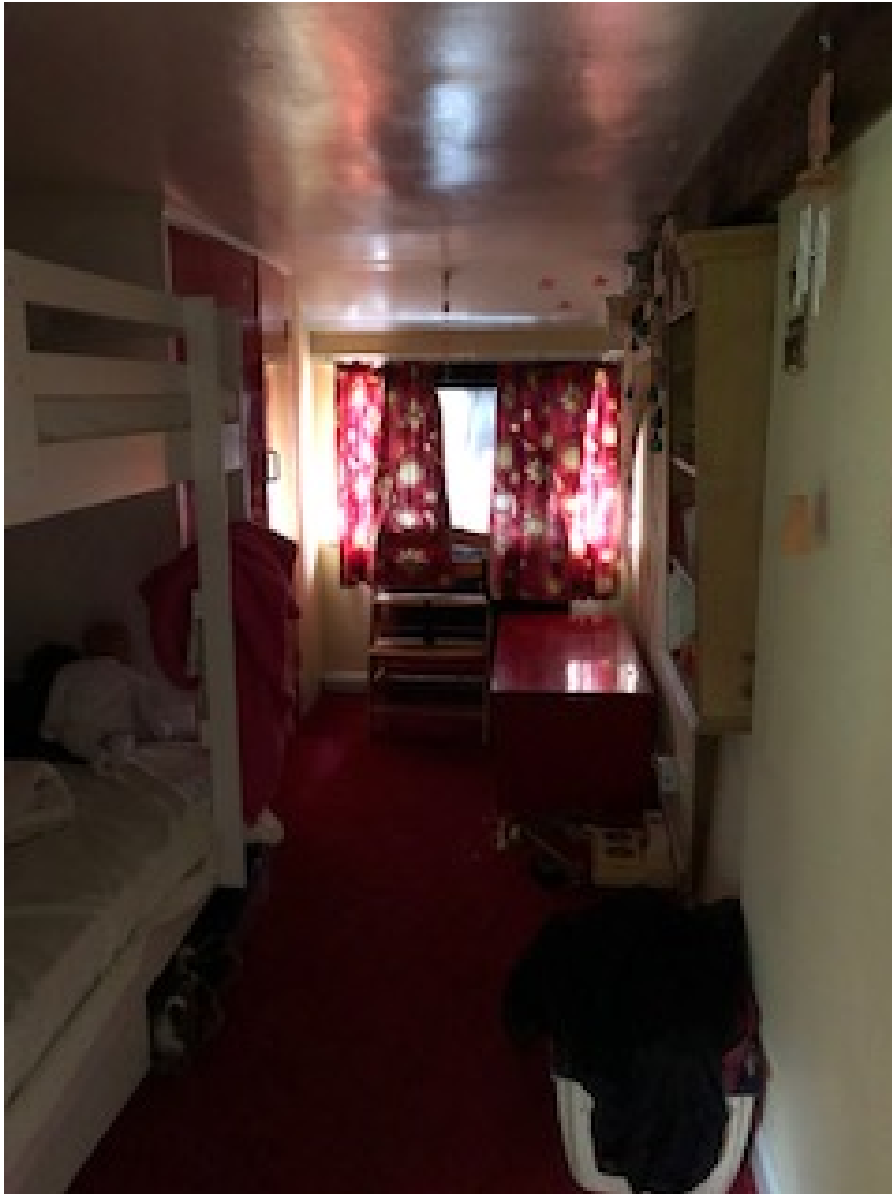
4.37 These rooms have been formed in the former service storage space and all date from the mid C20 with flush doors and joinery contemporary to this era. The end room remains unconverted to 'habitable space' with the framing exposed. This part of the building is not affected by the proposals.

Bedroom to cross-wing
