HERITAGE STATEMENT

Home Farm, North Green, Parham IP13 9NR

September 2019

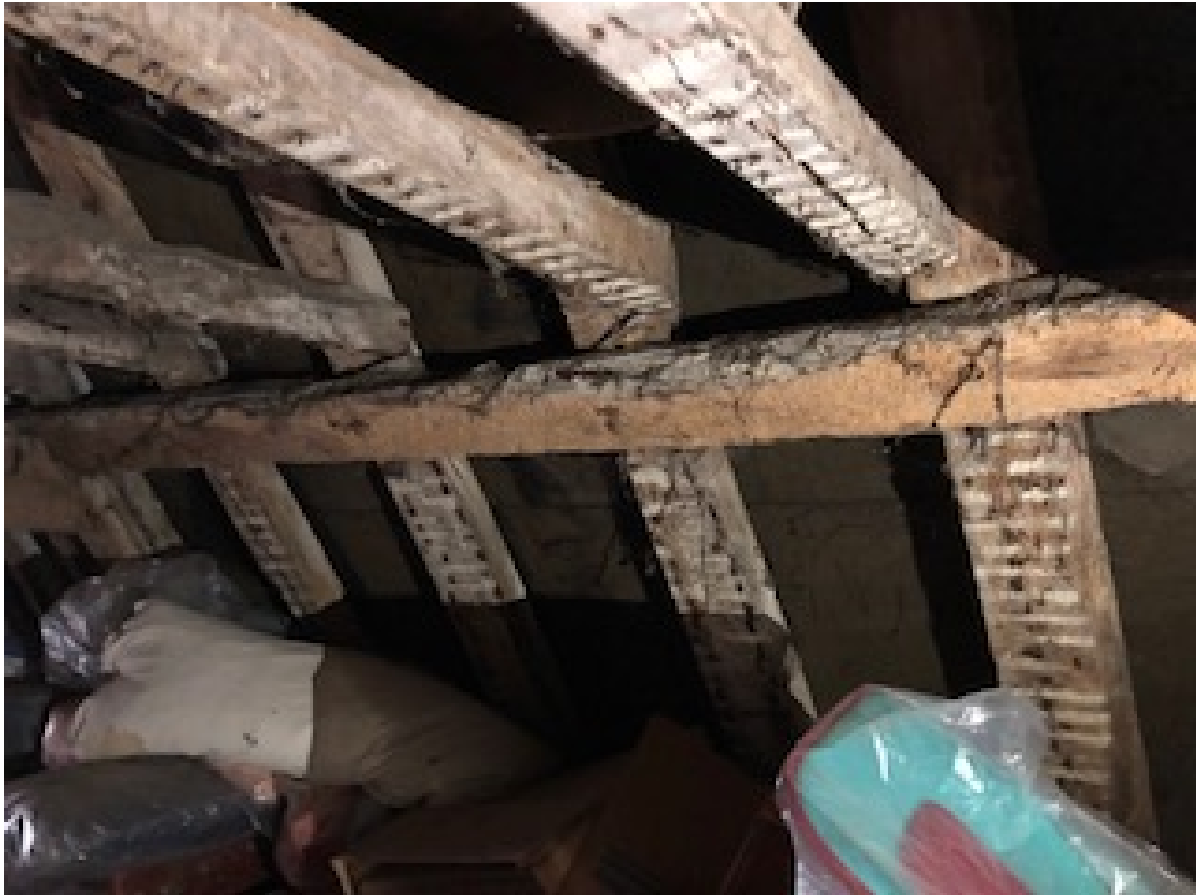
4.38 A attic stair gives access to the roof space to the cross-wing. This area has evidence of having been lathed and is boarded thus appears to have been habitable space but is currently used only for storage.

Evidence of laths

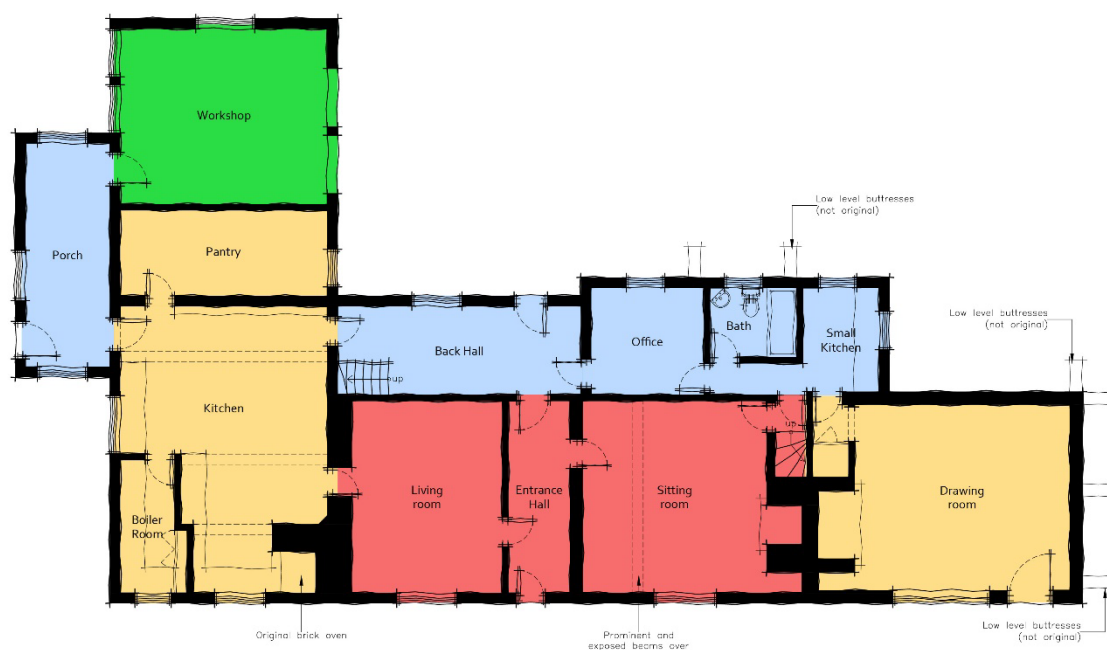
SUMMARY DIAGRAM OF SIGNIFICANCE

4.14 An analysis of both the external elevations and on a room by room basis has been carried out to consider the heritage significance of the component parts using the criteria set out in the table below. Given the house is Grade II Listed the right hand column is applicable with no exceptional features identified. The findings are summarised on the floor plans at the end of this section.

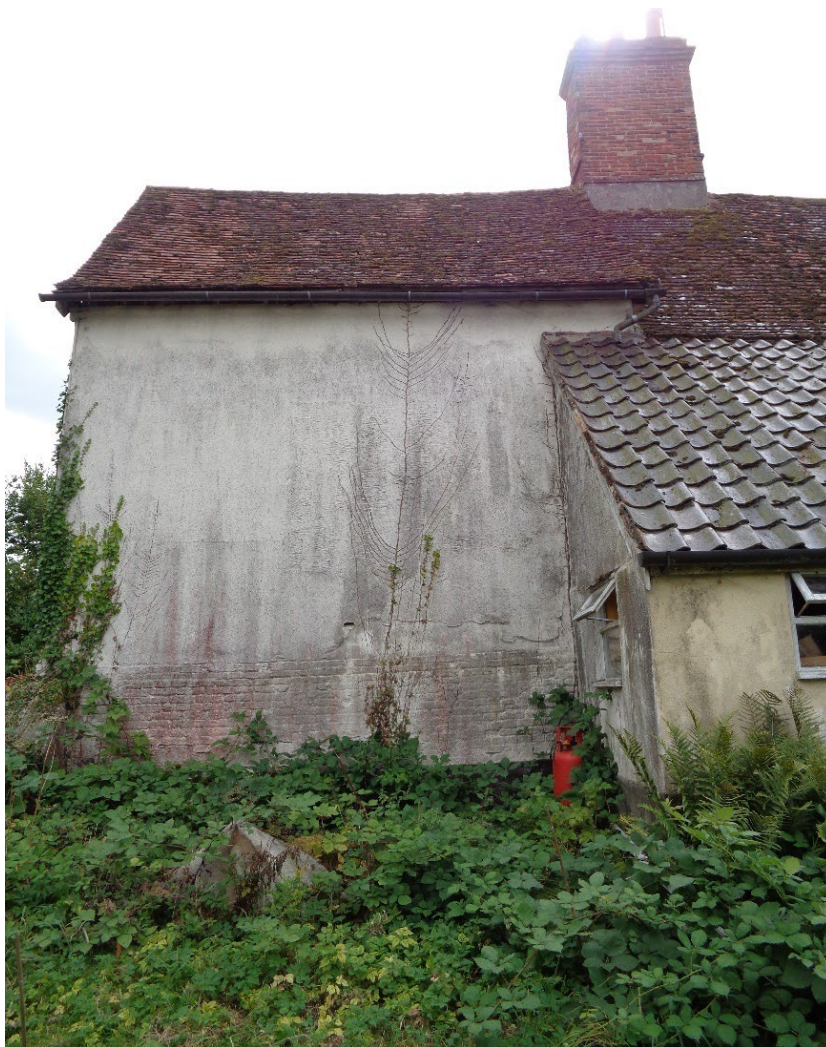
7.7 The proposal also seeks to extend the rear extension to include the eastern element of the building where a two storey structure is proposed forming a gabled cross wing. This format responds to the cross wing to the opposite end of the building , although it is not proposed to be the same length as the existing wing and is appropriate for the building. It should be noted that the unimplemented permission granted in 2000 (C/00/0671) granted permission for a single storey extension in this location. As the photo below shows this elevation is currently blank and thus there will be no concealing of any existing exposed historic windows. The scale and form of the extension is considered to be appropriate for the property and comply with the criteria of emerging Local Plan Policy SCLP11.4 Listed Buildings.

Eastern end of rear elevation.

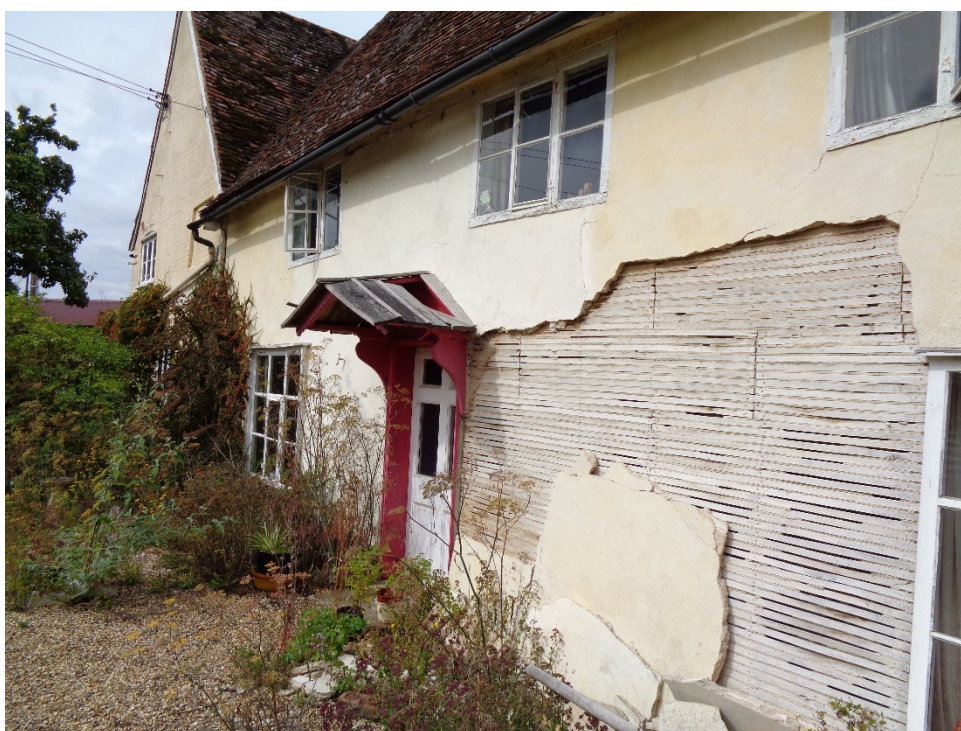
7.8 The existing principal entrance central to the front elevation and the second entrance to the eastern side are both enclosed by canopy porches which are in a poor condition. An enclosed porch is sought to the doorway at the eastern end of the main range so that one does not enter the room directly as existing to try and improve the heat loss from this part of the building. The porch will also serve to protect the existing external door to be retained in situ. The main entrance door does not need this 'airlock' facility as it opens onto the existing hallway. These structures appear to have been in situ in the 1920's but do not follow the simple Suffolk vernacular style of the building with their classical detailing. The proposed more traditional porches proposed to each entrance are considered to be of a suitable scale and more in keeping with the building.
